**Introduction:** This report presents work carried out by \_\_\_\_\_ Contracting Inc., in 19xx. The Figure to the right shows the location of area in relation to the inlet south of the city's downtown area as it was around 1980, roughly a decade before our work was done. The history of industrial activity is fairly complex, and covers over 100 years. For example, the photograph below shows some of the wood waste mixed in with the fill under the pavement at this location. More details about the history are available elsewhere, but are beyond the scope of this summary.

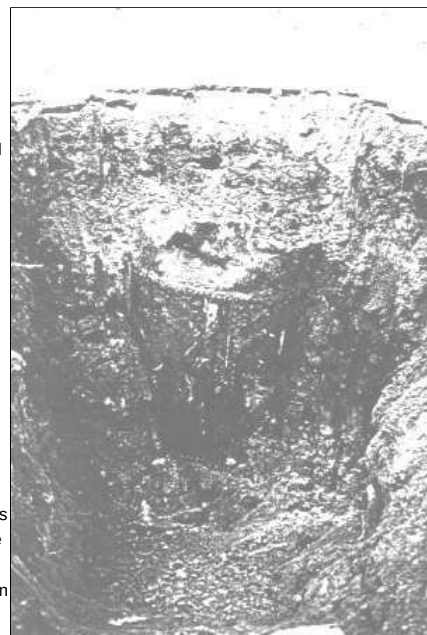
PCB concentrations were measured in 58 soil samples with results as shown below left. Most of the contamination was found within the depth range of 1m to 3m, which corresponds to the fluctuation of the water table. Samples from five standpipe locations were used to characterize the oil itself, in terms of carbon distribution, viscosity, specific gravity and flashpoint. The oil / water contact was found to be blurred even after samples gathered from standpipes had been left to stand for 24 hrs. The diffuse layer between oil and water was inferred to consist of emulsified oil possibly resulting from weathering due to microbial activity over the extended time period. Note that this probably has important implications for detection using geophysics for at least two reasons: i) the interface between water and oil is not manifested as a distinct transition in physical properties, and ii) there are in effect three fluids rather than two - water, oil, and the mixture.
